TECH NOTE

LOOSENING THE WATER PUMP BEFORE BELT INSTALLATION IS VITAL TO CORRECT TENSION ON HOLDEN & DAEWOO 16V PETROL ENGINES

BULLETIN: TSB003_AU

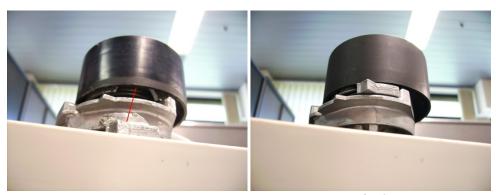
Fig. 2 Fig. 3

If the tensioner bolt is not loosened, the pointer of the tensioner will hit the cold stop violently. This could seriously damage the pointer, resulting in a rupture (later on). Proceeding this way, in order to be able to install the new belt, the pointer of the tensioner has to be pushed back. When trying this with a screwdriver, you risk that the screwdriver will slip off the pointer (because of the high spring tension) which will again hit the cold stop. Fig. 3 shows where the pointer is situated on a good tensioner (in its rest position).

Also, leaving the old tensioner on without loosening the tensioner bolt is not the correct procedure to follow.

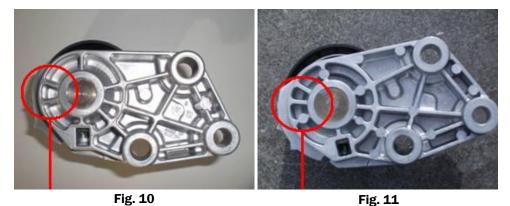
In addition, watch out for counterfeit tensioners which can be widespread in certain markets (Fig.10 and 11 are 0E, Fig. 12 is counterfeit).
